## **U.S. Geological Survey**

# **Serious Accident Investigation Factual Report**

## **Fatal Diving Accident at Torch Bay, Alaska**

**Date of Accident  
August 7, 2019**

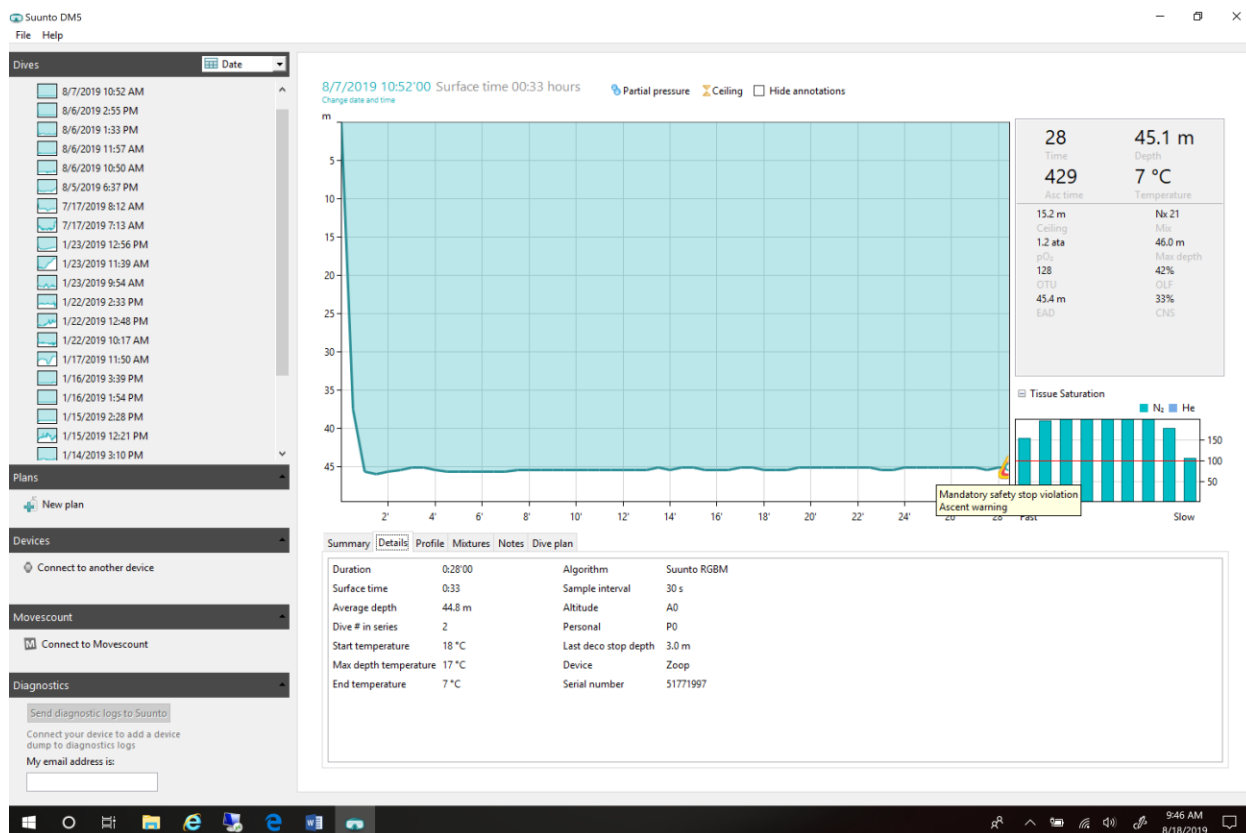
program. Some of the dives imported into the Suunto software appeared to display correctly, and some of the imported dives did not appear to display correctly. The import of the incident dive did not appear to be displaying the recorded information correctly. The dive information that was manually recorded from the dive computer showed a maximum depth of 28 fsw (8.53 meters seawater [msw]). The Suunto DM5 software showed a maximum depth of 45.1 meters (approximately 148 feet). The software did display a “Mandatory safety stop violation Ascent warning” at the end of the dive. With the displayed information differing from the information when viewed manually, the SAIT had little confidence in the information displayed by the DM5 software. There was also an “Ascent Warning” indicated in the last 30 seconds of the dive observed by the SAIT using the dive computer’s manual dive profile review function.

Figure 2: Screen shot of incident dive from PC version of the Suunto DM5 software showing incorrect depth information.

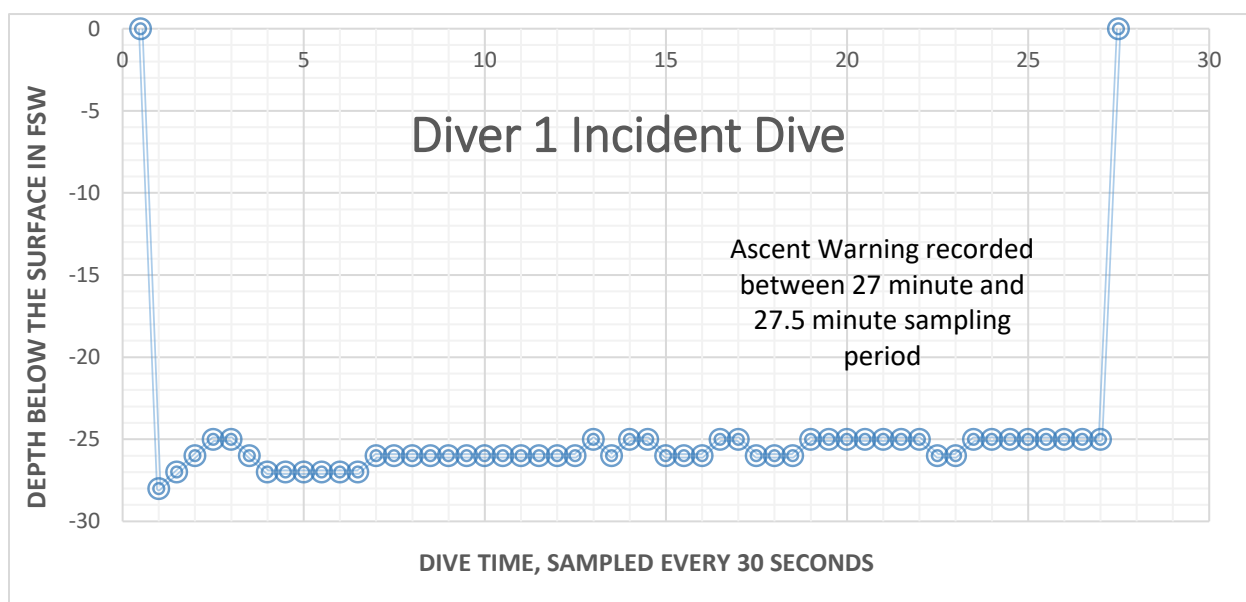
The data recorded manually from Diver One’s dive computer was used to produce a graph of the dive profile ([See Figure 3](#)). The rapid ascent alarm was recorded independently by the dive computer as a violation of its programmed maximum recommended ascent rate. Because the ascent rate was recorded in between the computer’s 30 second sampling intervals, the actual ascent rate is unknown.

Figure 3: Hand plot of Diver One's dive computer data showing depth in fsw below the surface recorded every 30 seconds.

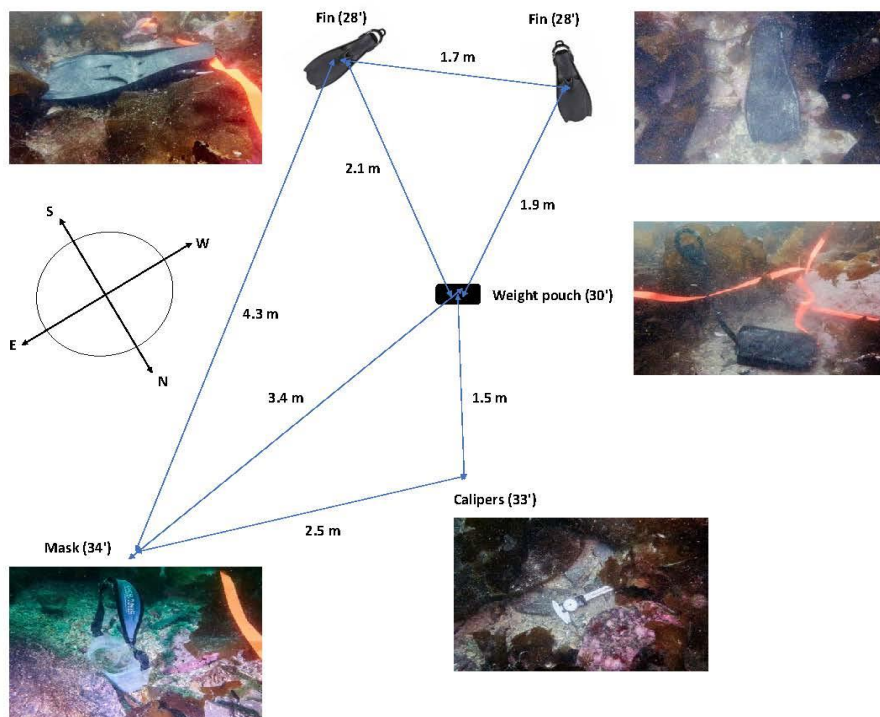
Figure 4: Diagram of the items found on the bottom at the incident dive site.

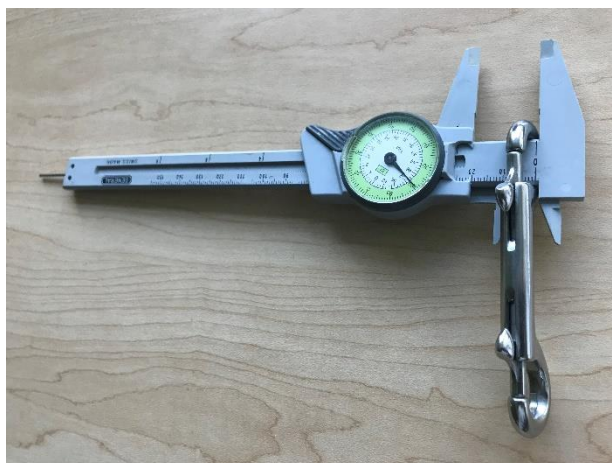
Photo 1: Example of how Diver One used the stainless steel clip attached to his data slate to hold his calipers.

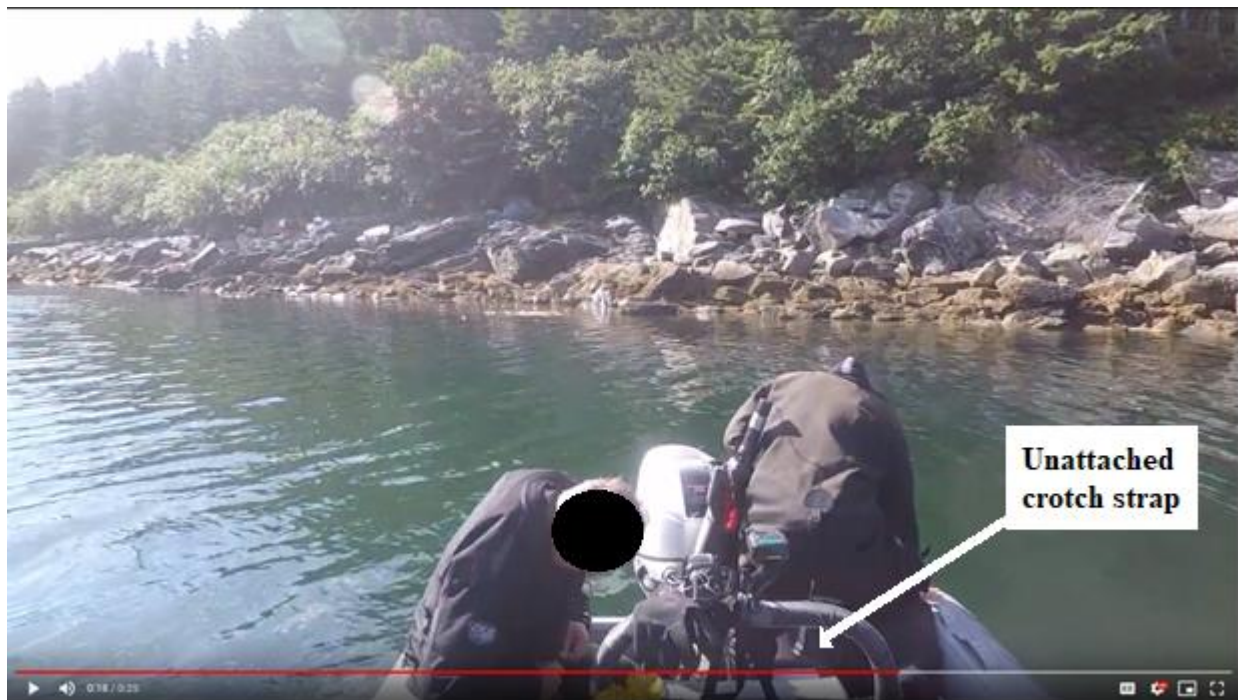
Photo 2: Screen grab image from pre-incident video showing Diver One from the back with the drysuit crotch strap disconnected

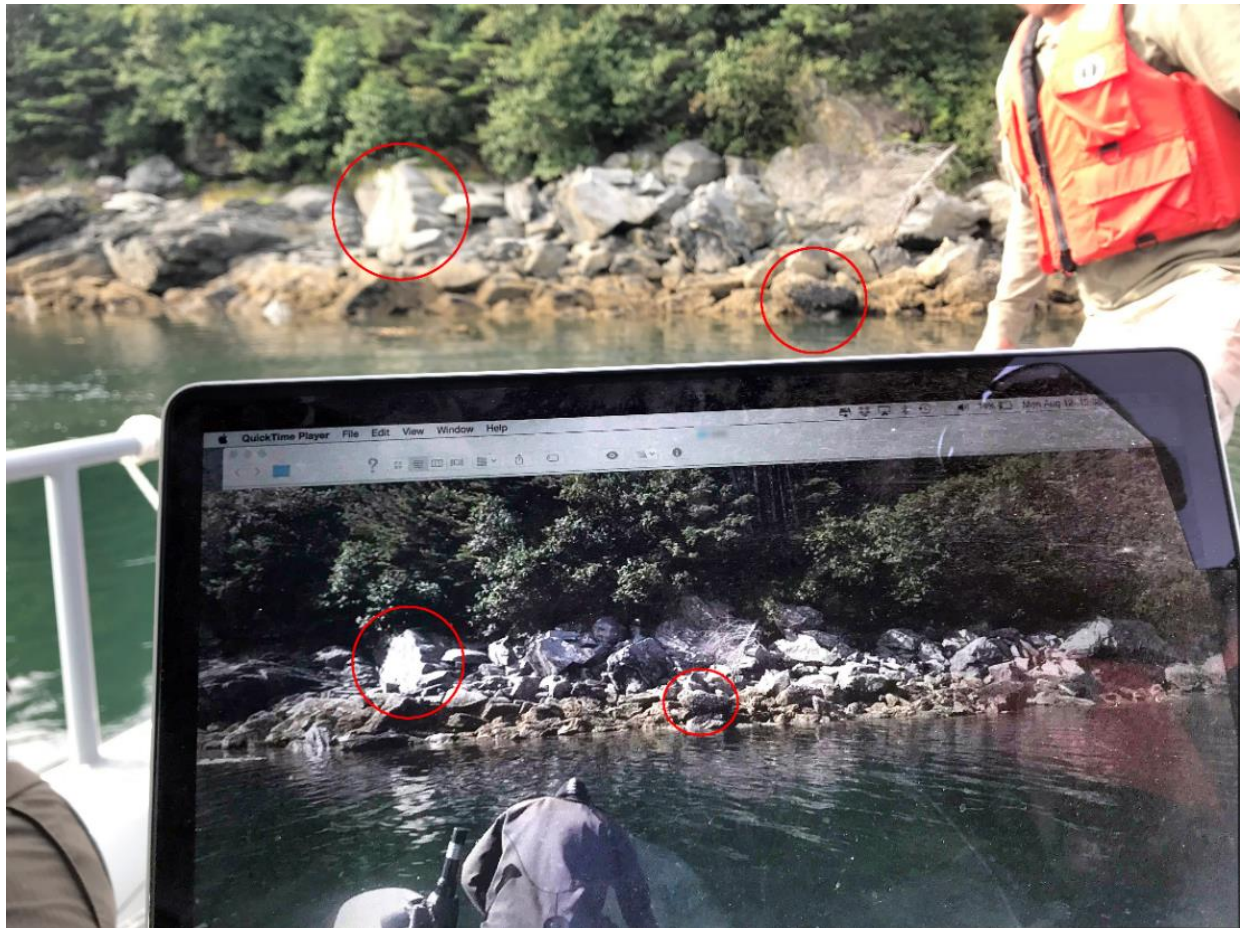
Photo 4: Video taken before the incident dive being used by SAIT to identify the dive incident location. Note several distinguishable features including prominent flat rock face and mussel covered rock.

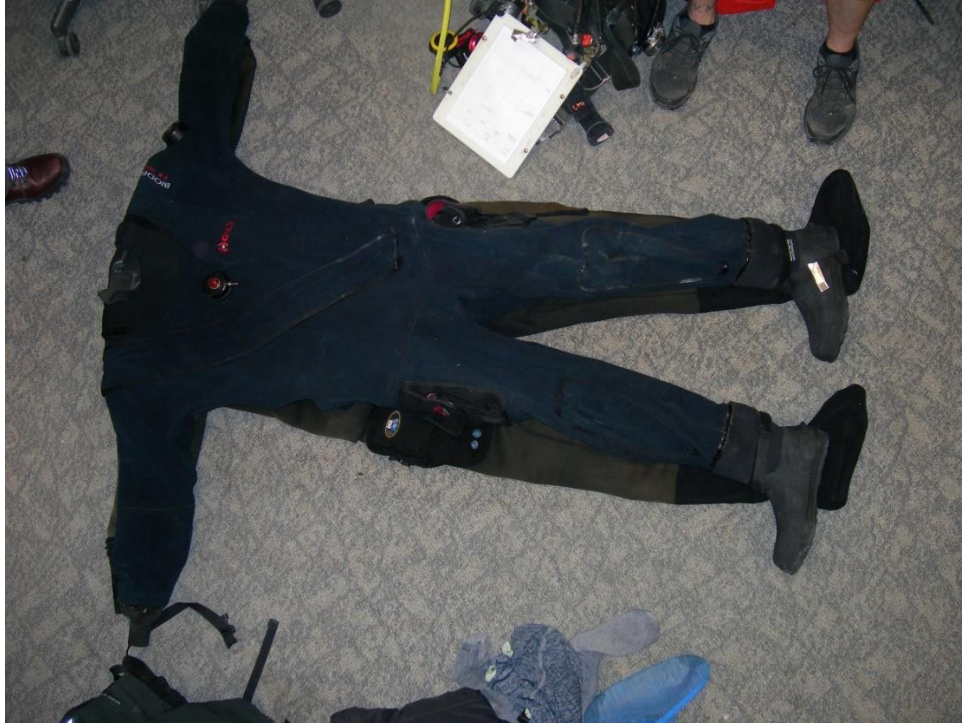
Laying the incident suit flat on the ground with the telescoping fabric fold properly adjusted and laying Diver One's personal suit on top of it found the suits to be similar in size ([See Photo 5](#)). Unfolding the telescoping fabric fold and repeating the comparison found the incident suit could extend approximately 10 (ten) inches (25.4 cm) beyond the end of Diver One's personal suit ([See Photos 6 & 7](#)).

Photo 5: Diver One's personal drysuit laid on top of the drysuit worn during the incident dive  
NOTE: The fabric fold of the incident drysuit is in the folded position as it is designed to be worn.

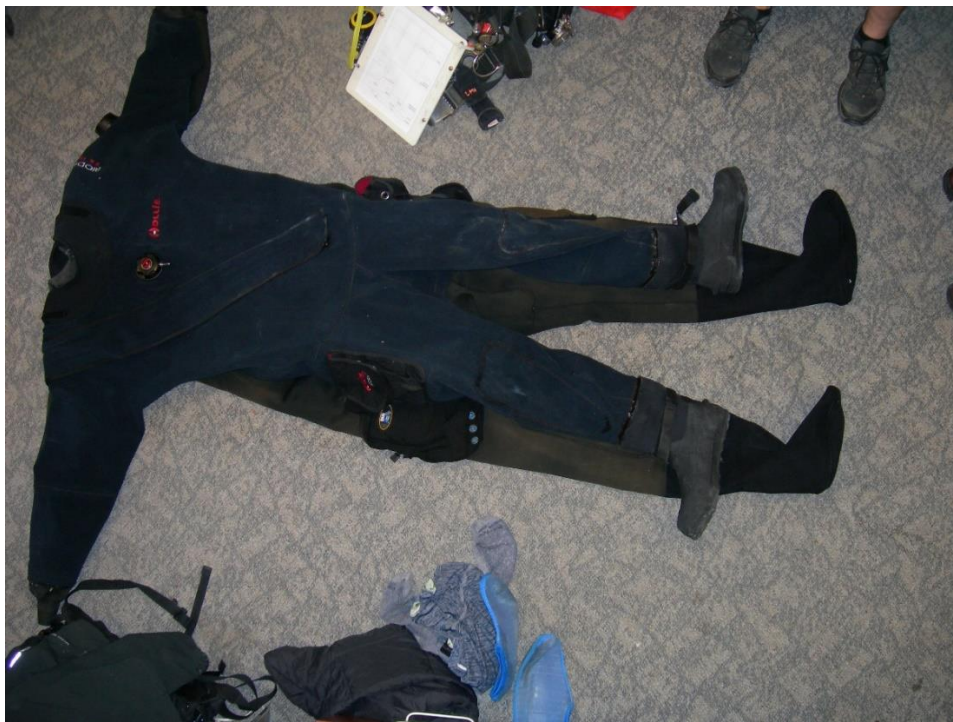
Photo 6: Diver One's personal drysuit laid on top of the drysuit worn during the incident dive  
NOTE: The fabric fold of the incident drysuit is fully extended toward the diver's feet.

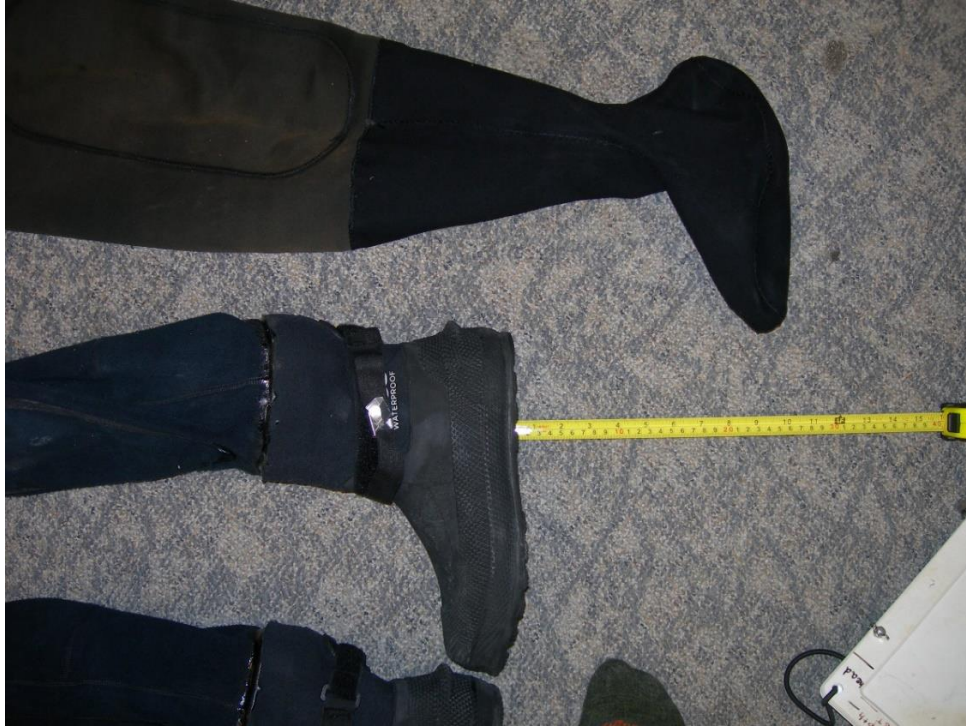
Photo 7: Comparison of the suit worn during the incident dive (above) and Diver One's personal drysuit (below). With the excess fabric from the fold of the DUI CF200 drysuit extended toward the diver's feet, approximately ten inches of material could have protruded beyond Diver One's feet.

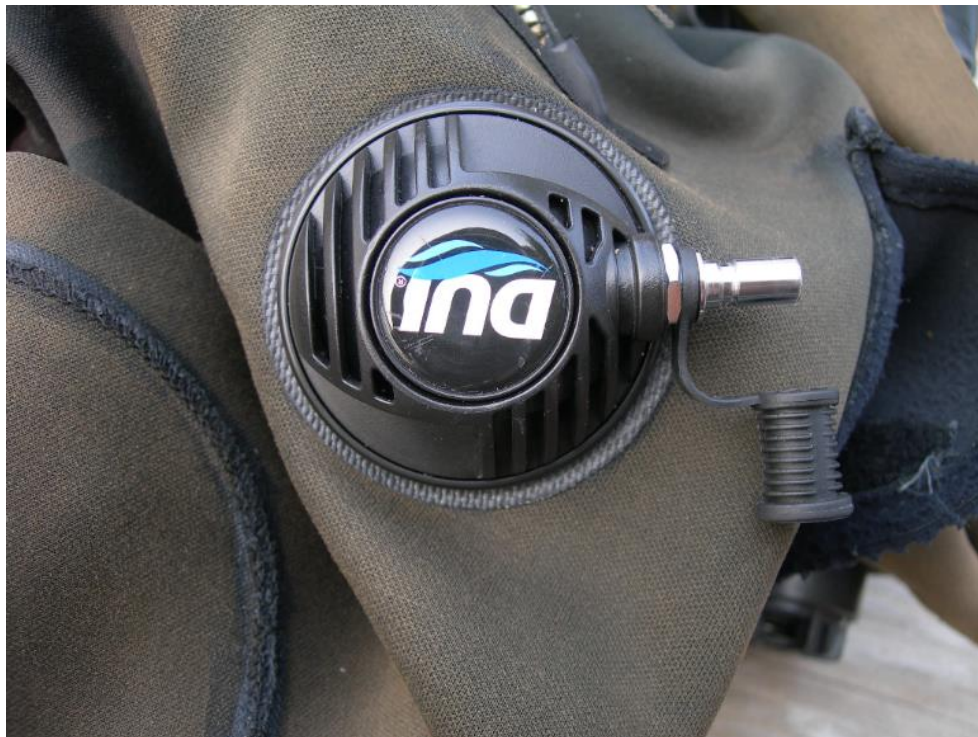
The inflator valve of the suit worn during the incident manipulated smoothly and appeared to function properly. When attached to the drysuit inflator hose of Diver One's regulator, it sealed properly and did not leak gas into the suit. Pushing the inflator button caused gas to pass through the valve. Releasing the button caused gas to stop passing through the valve. There was no appreciable lag between the release of pressure on the button and the valve stopping the flow of gas into the suit.

The inflator valve on the suit worn during the incident has a hard exterior housing that extends near the top of the inflator valve button. This exterior lip around the button would protect the button from accidental activation in most circumstances. While the top most edge of the button is not actually recessed below the edge of the hard exterior housing, simply coming in contact with an object that also contacted the housing lip would not be likely to activate the button. Activation of the valve would require a hard object that could push the button directly.

Photo 8: Detail of the inflator of the drysuit worn during the incident.

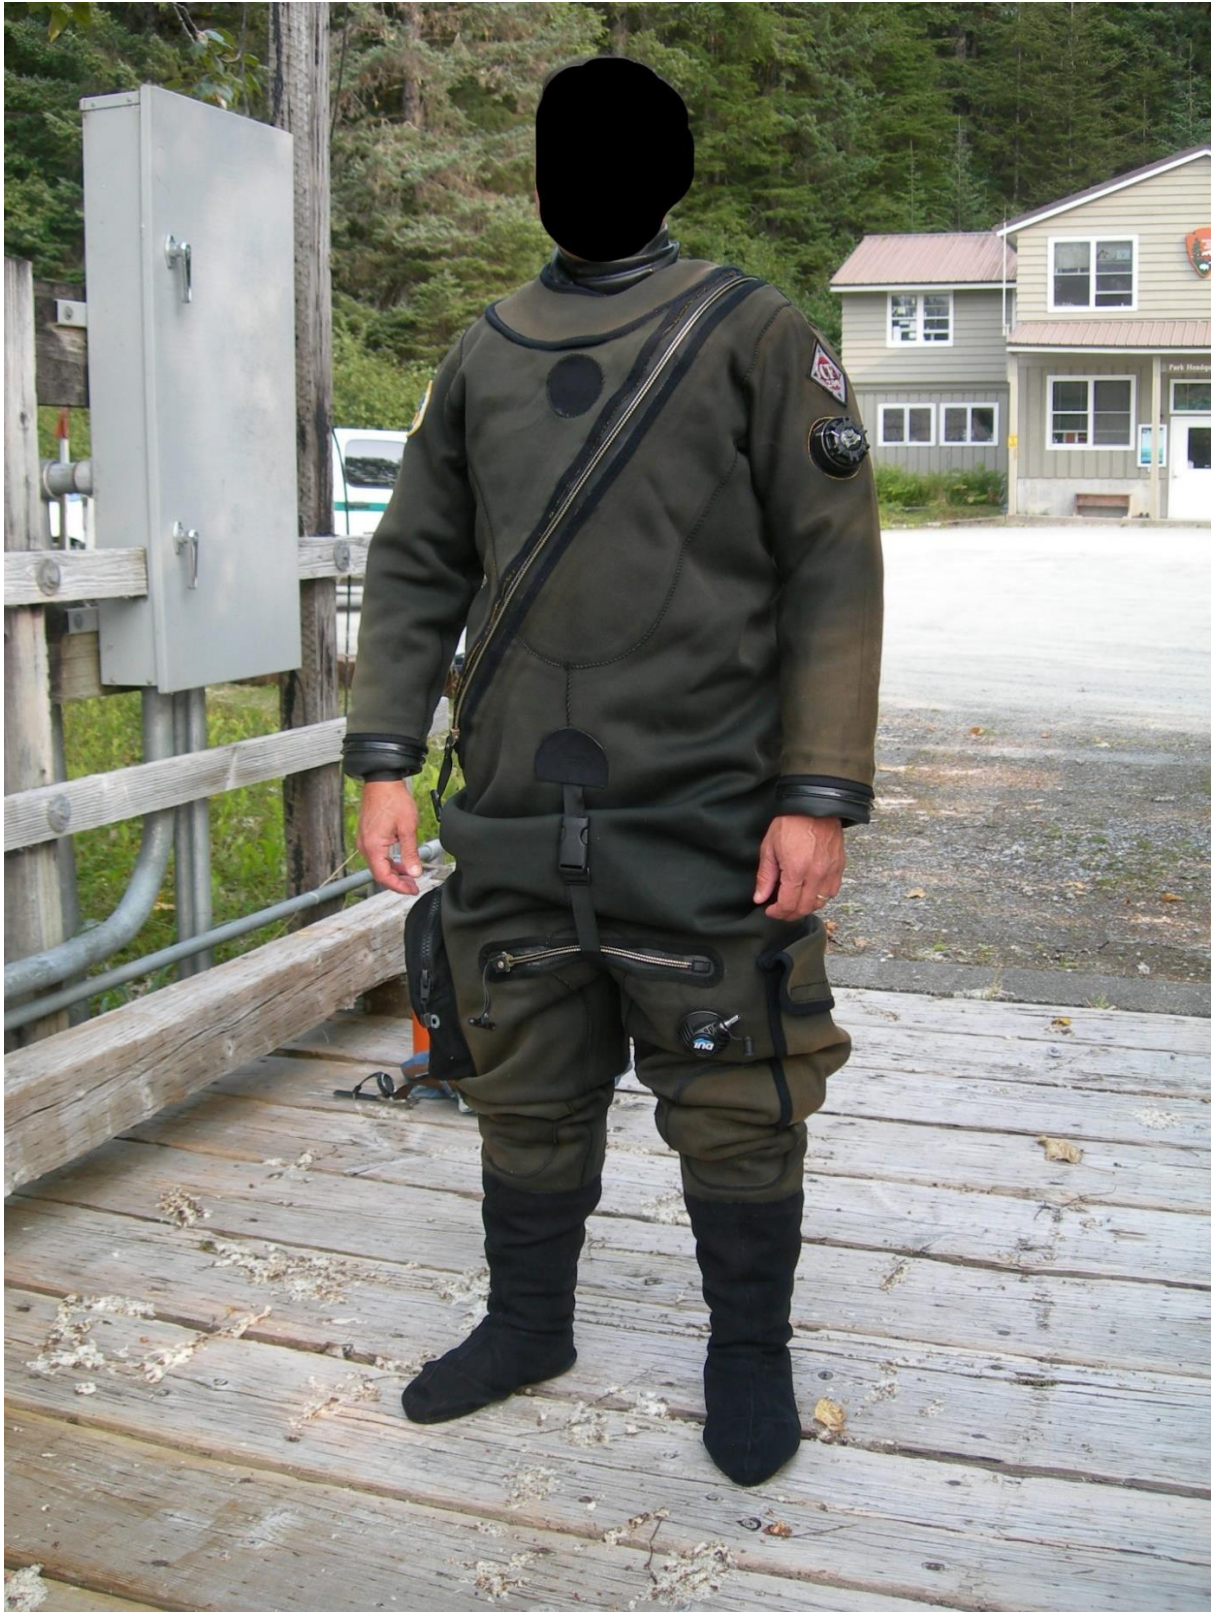
The suit was donned with the foot coverings worn by Diver One in place, and without suspenders in place. The fit of the suit was inspected with and without the crotch strap connected. ([See Photos 9 & 10](#)). The fit was determined to be a little large, but not unreasonably large if properly donned.

Photo 9: Demonstration of drysuit with crotch strap clip attached.

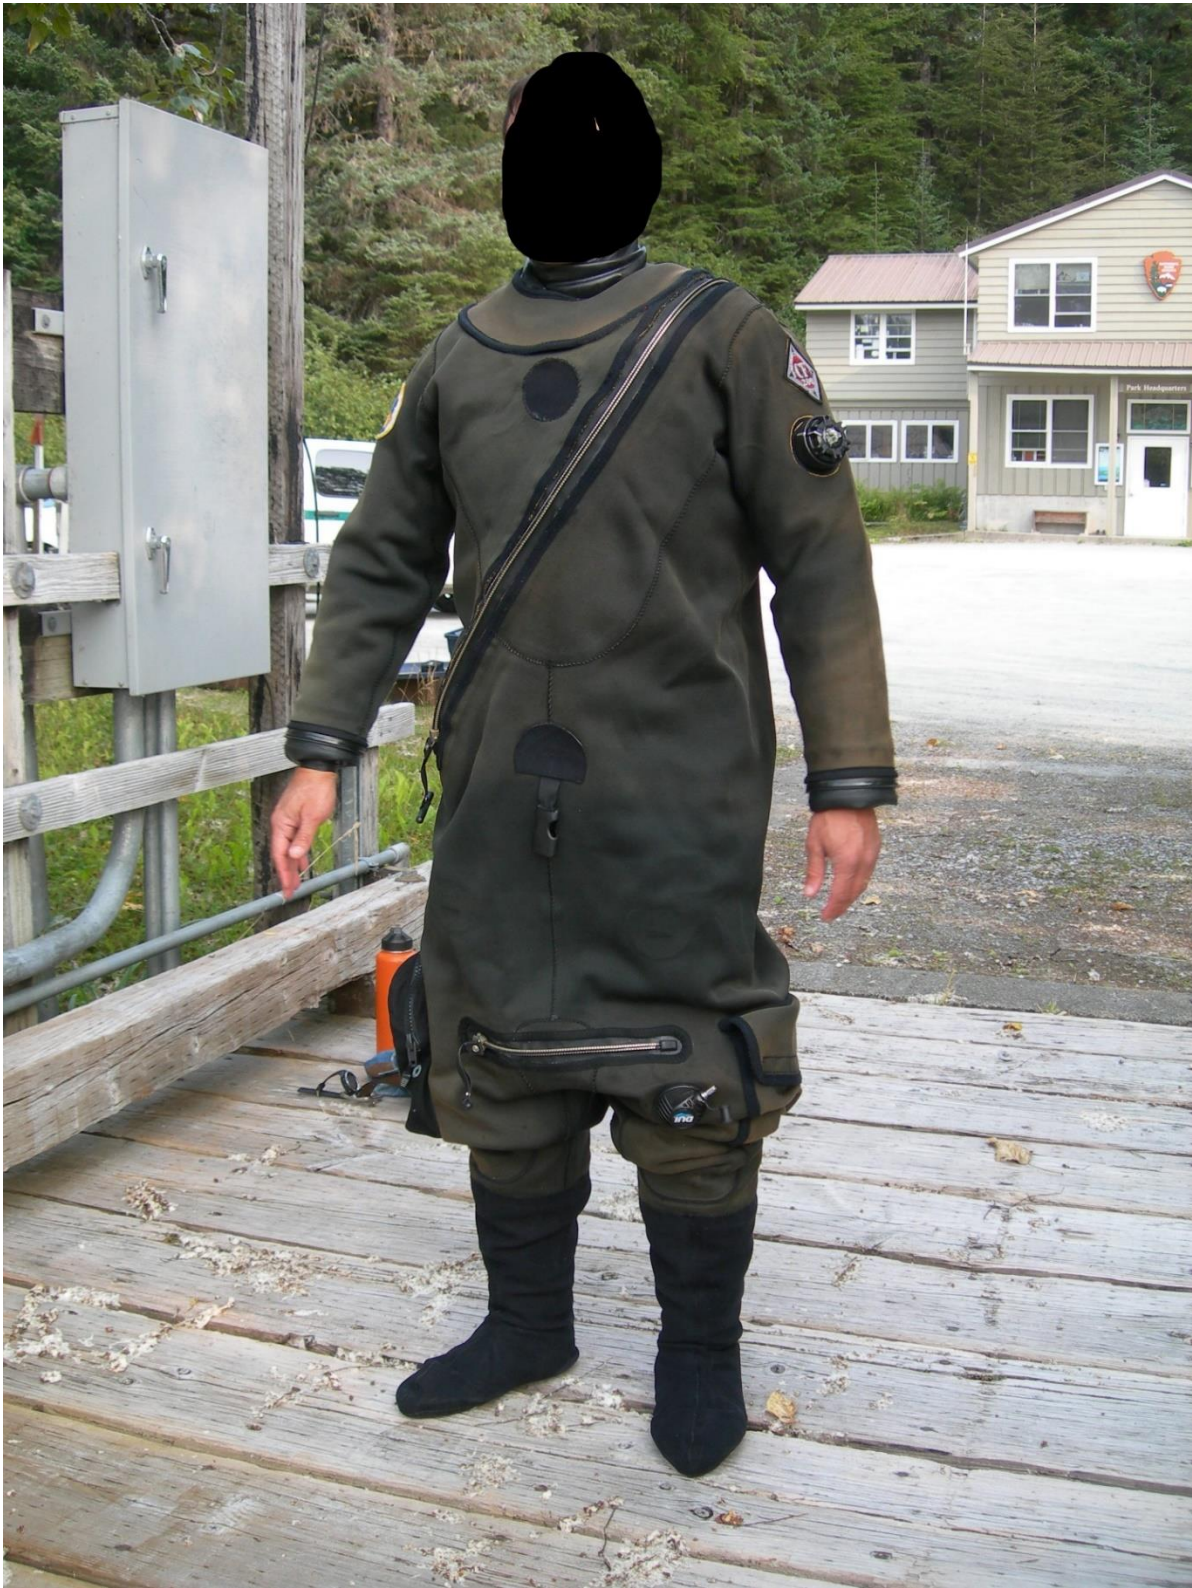
Photo 10: Demonstration of drysuit without crotch strap clip attached.

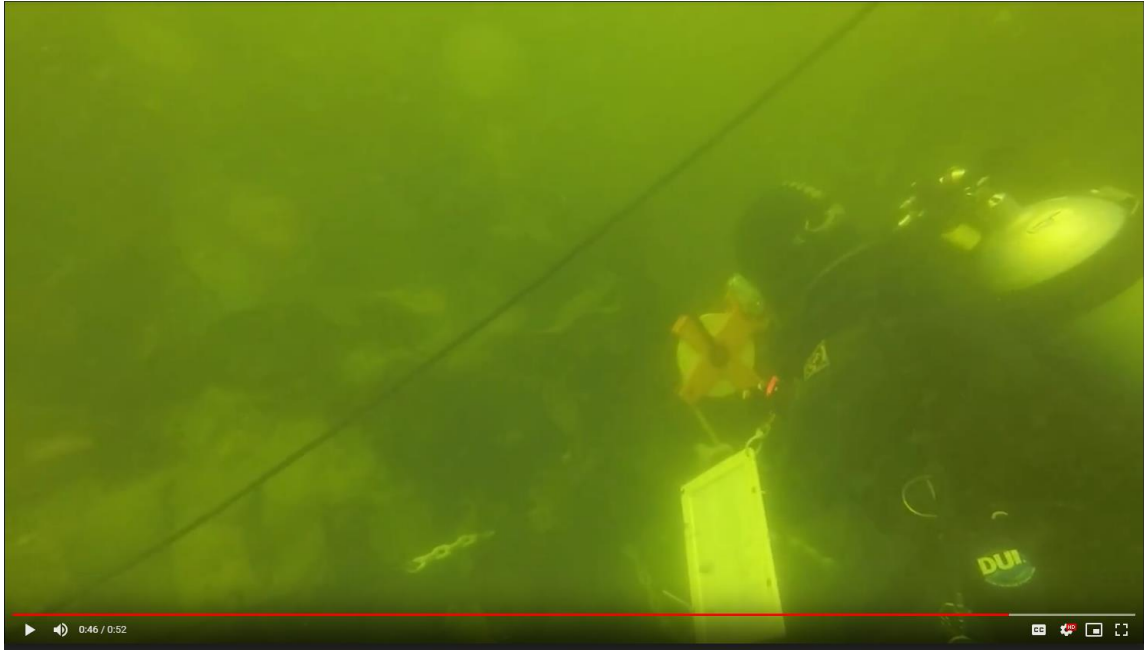
Photo 11: Screen grab image from the start of the incident dive showing Diver One from the left side. The “DUI” in the lower right hand corner is the left side weight pouch.

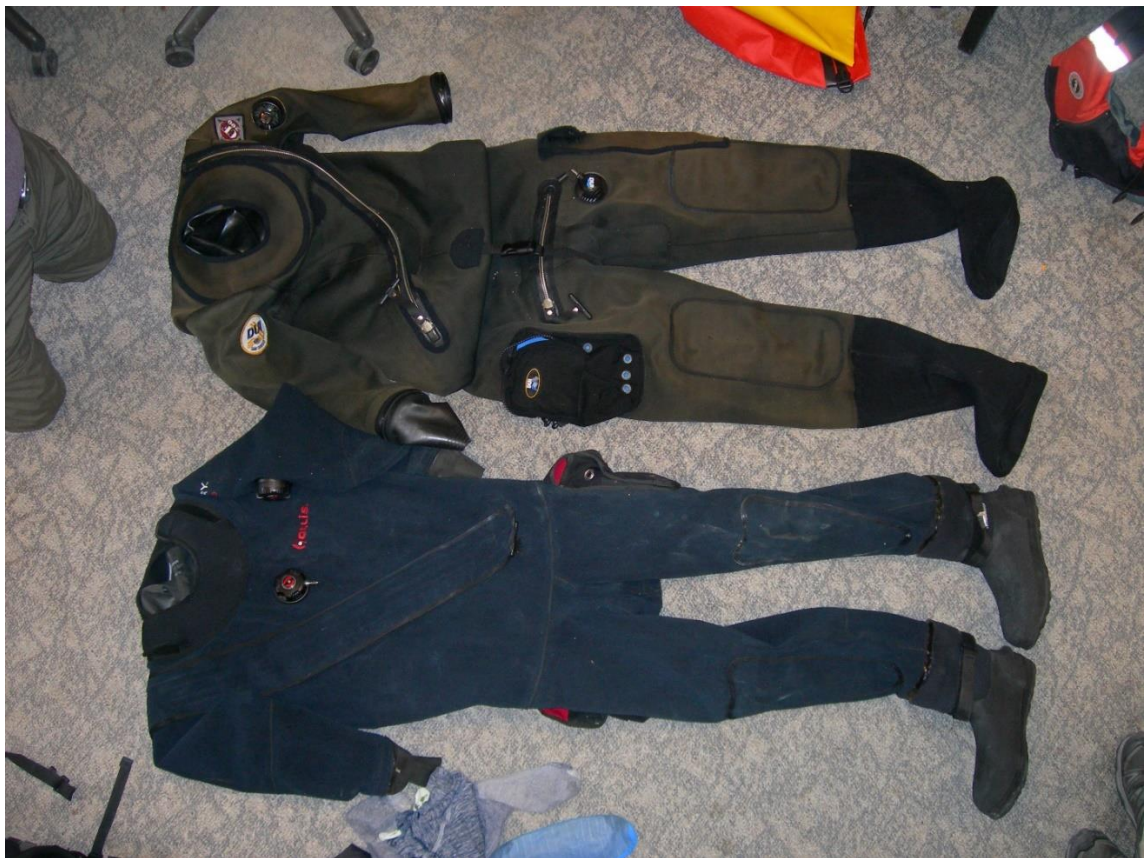
Photo 12: Side by side comparison of drysuits with crotch strap attached to DUI suit.

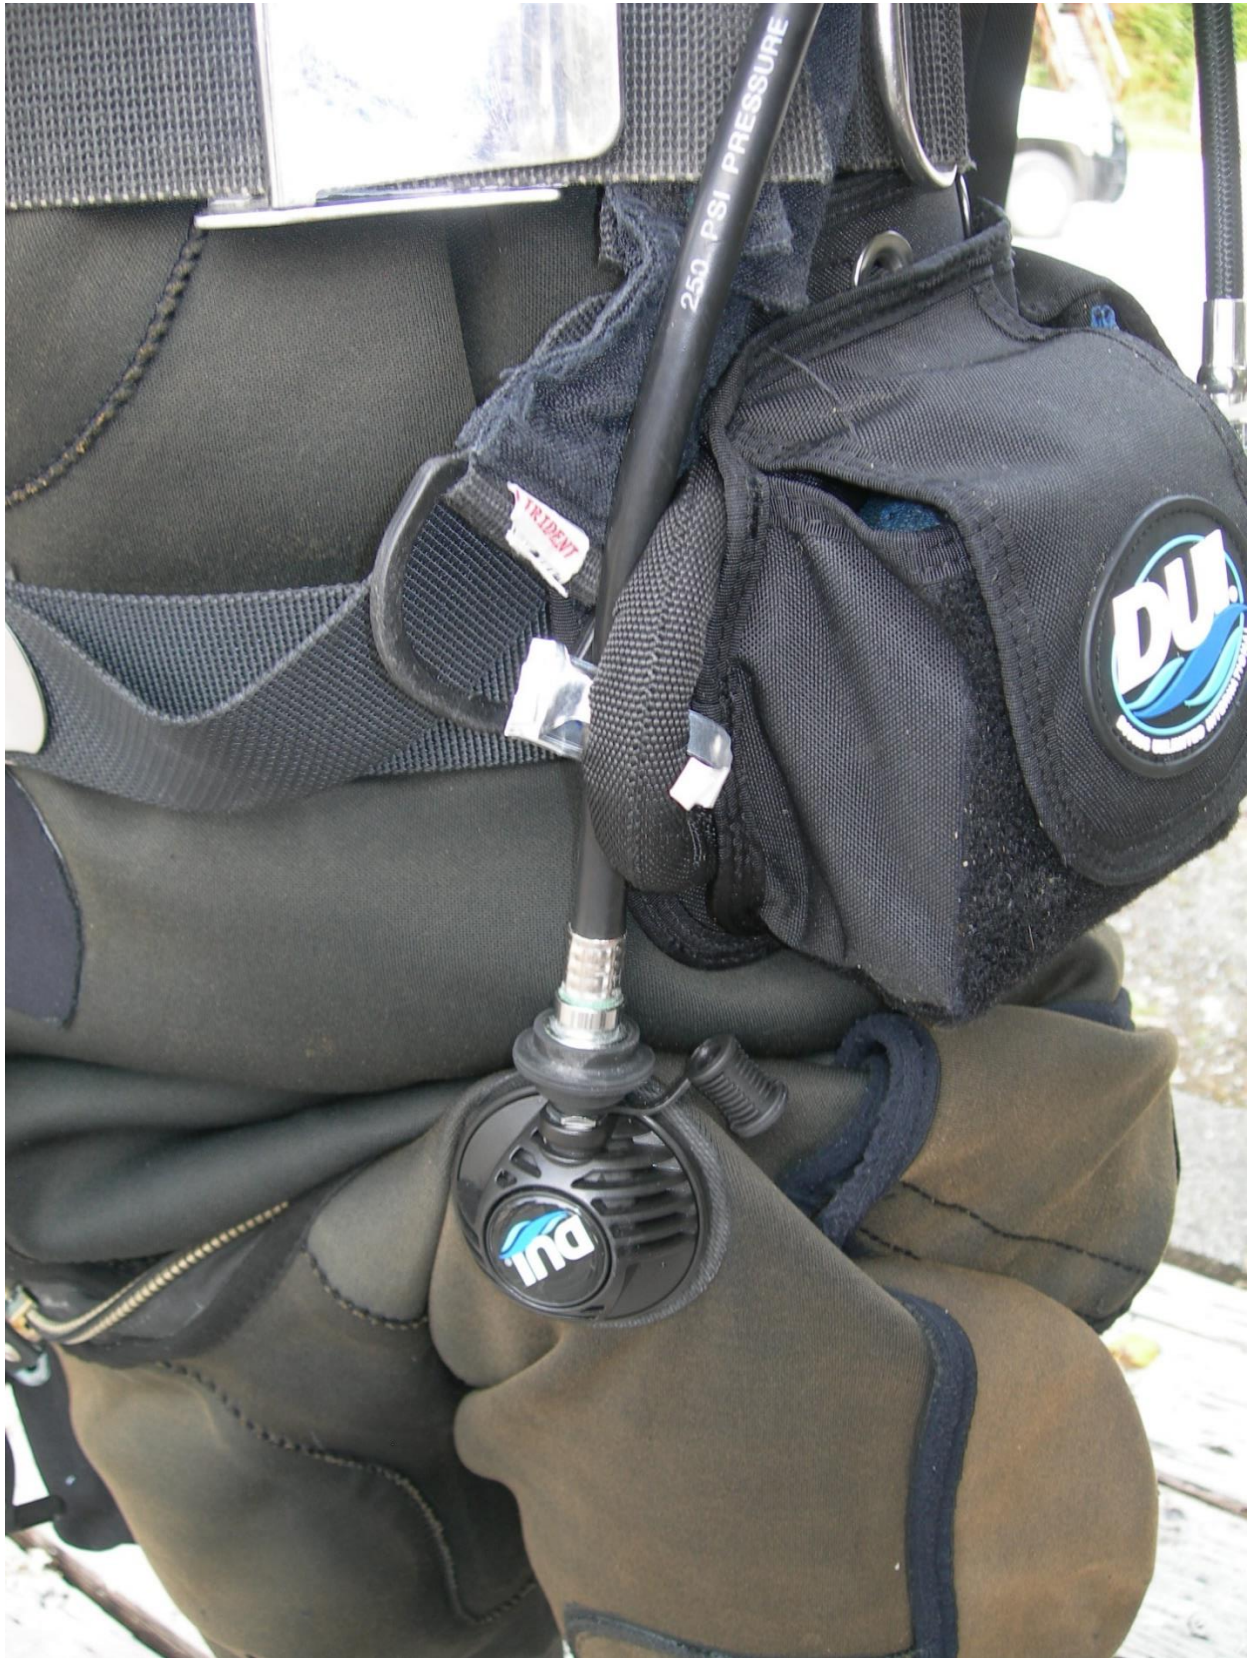
Inspection of the SCUBA unit found the drysuit inflator hose was of adequate length when using a drysuit with the inflator valve located on the diver’s chest. The length of the drysuit inflator hose on Diver One’s SCUBA unit was short when using a suit where the inflator valve was on the diver’s thigh.

Photo 13: Inflation hose pulling up drysuit and tight against left weight pocket.

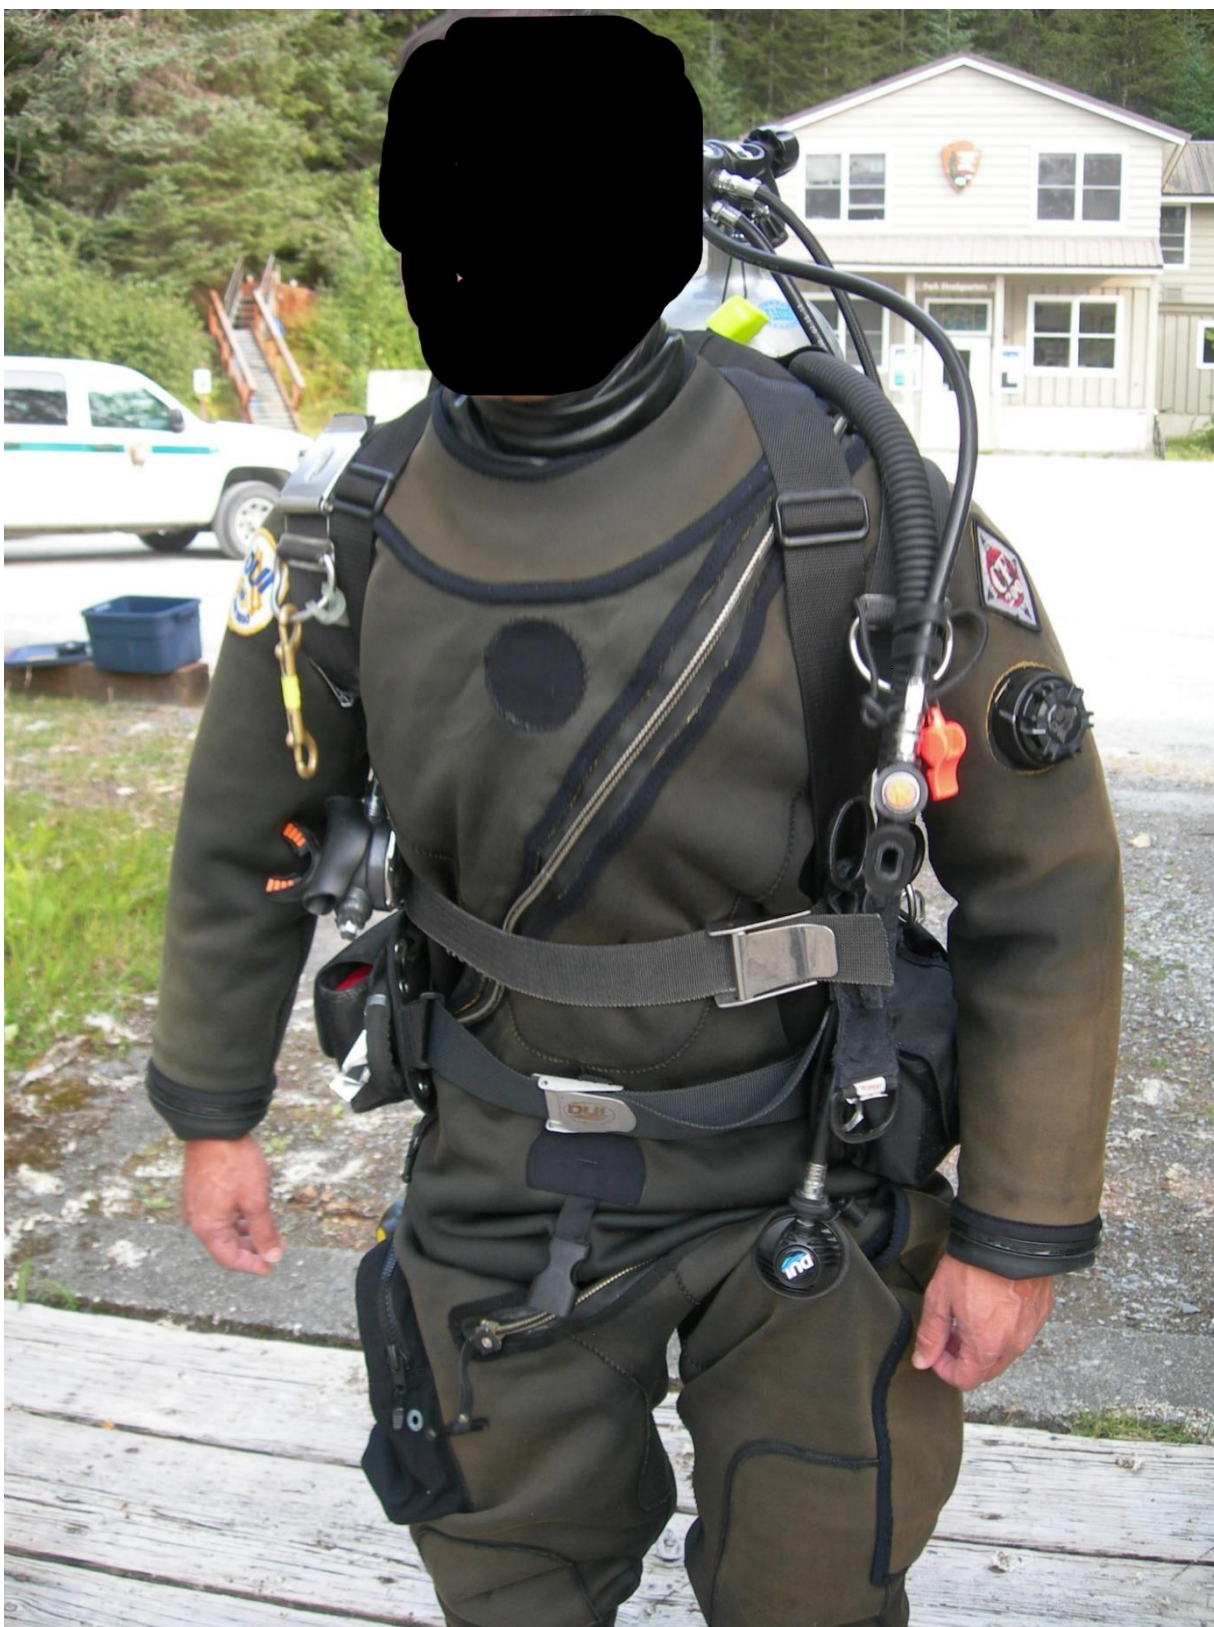
Photo 14: Diver One's drysuit inflator hose connected to inflator. Illustrating the tension on the hose and position relative to the weight pouch.

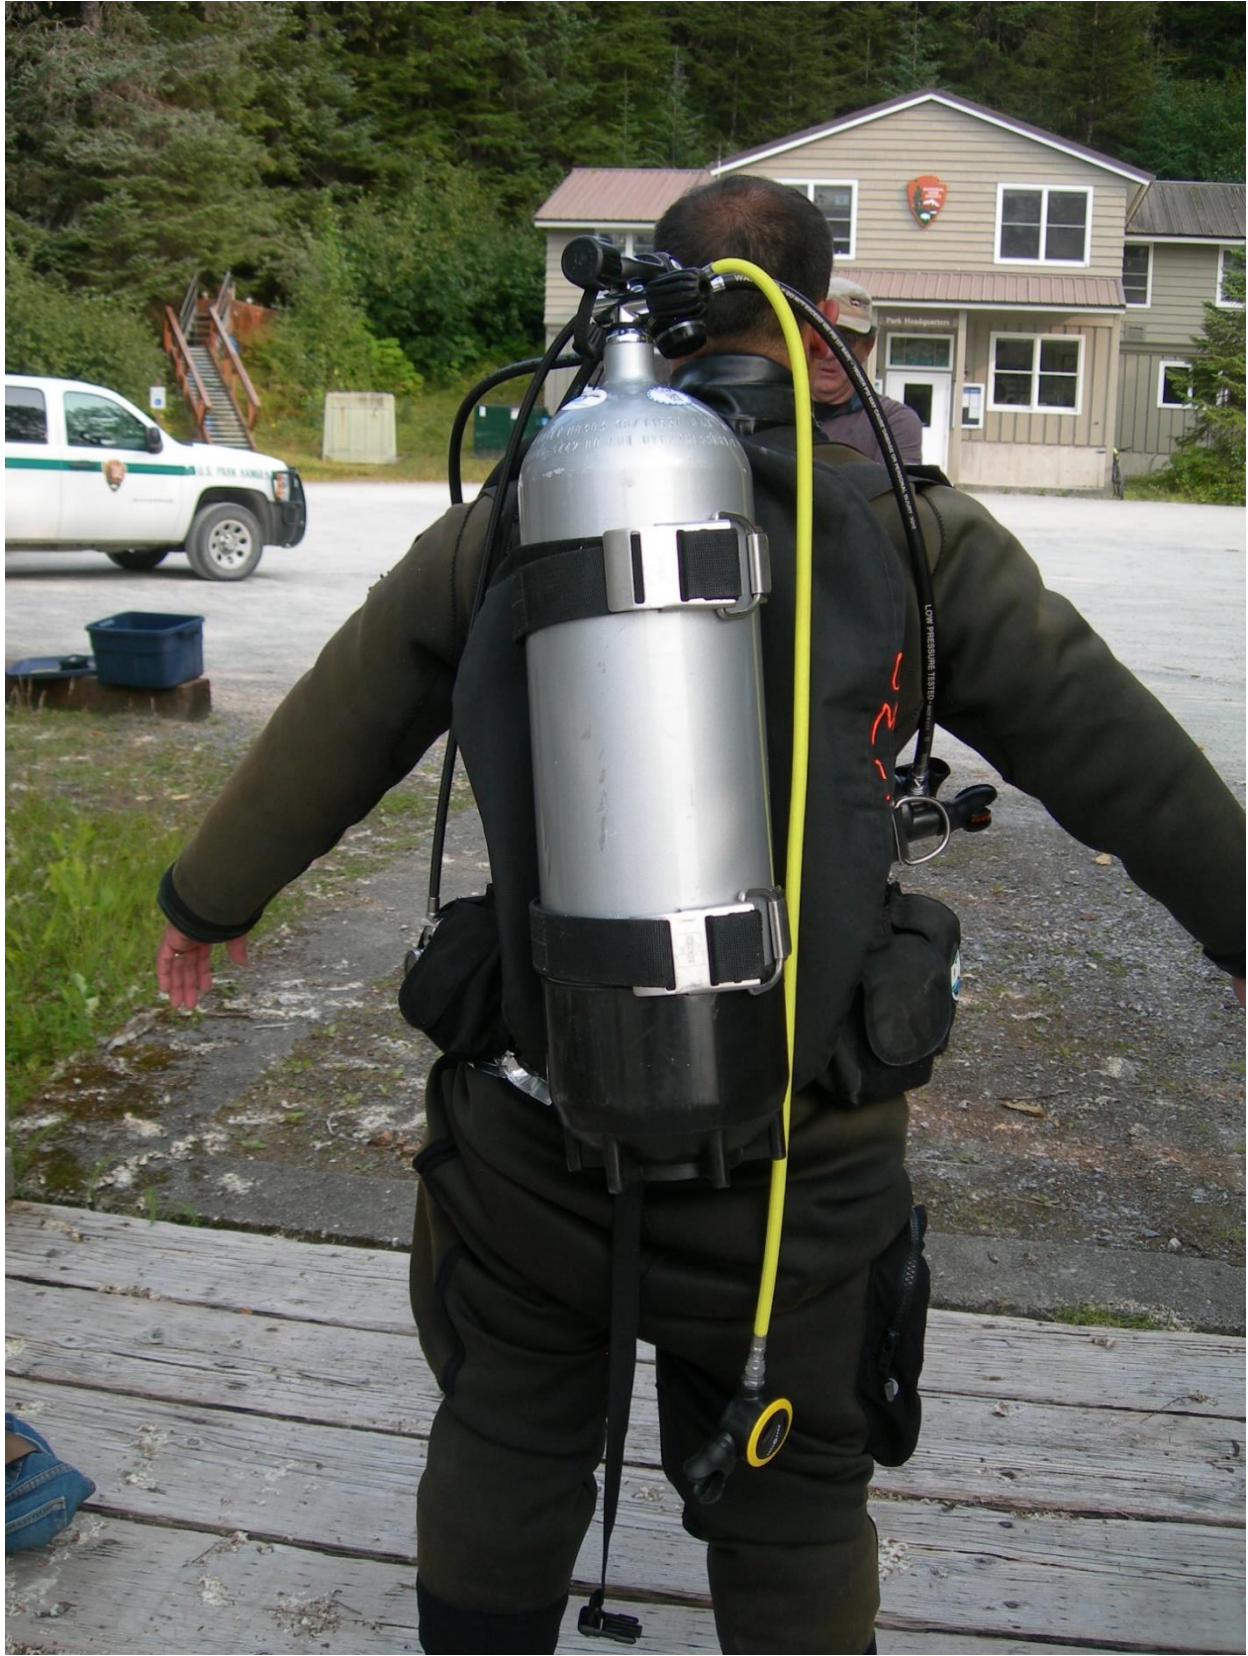
Photo 15: Cylinder canting caused by tension on inflation hose.

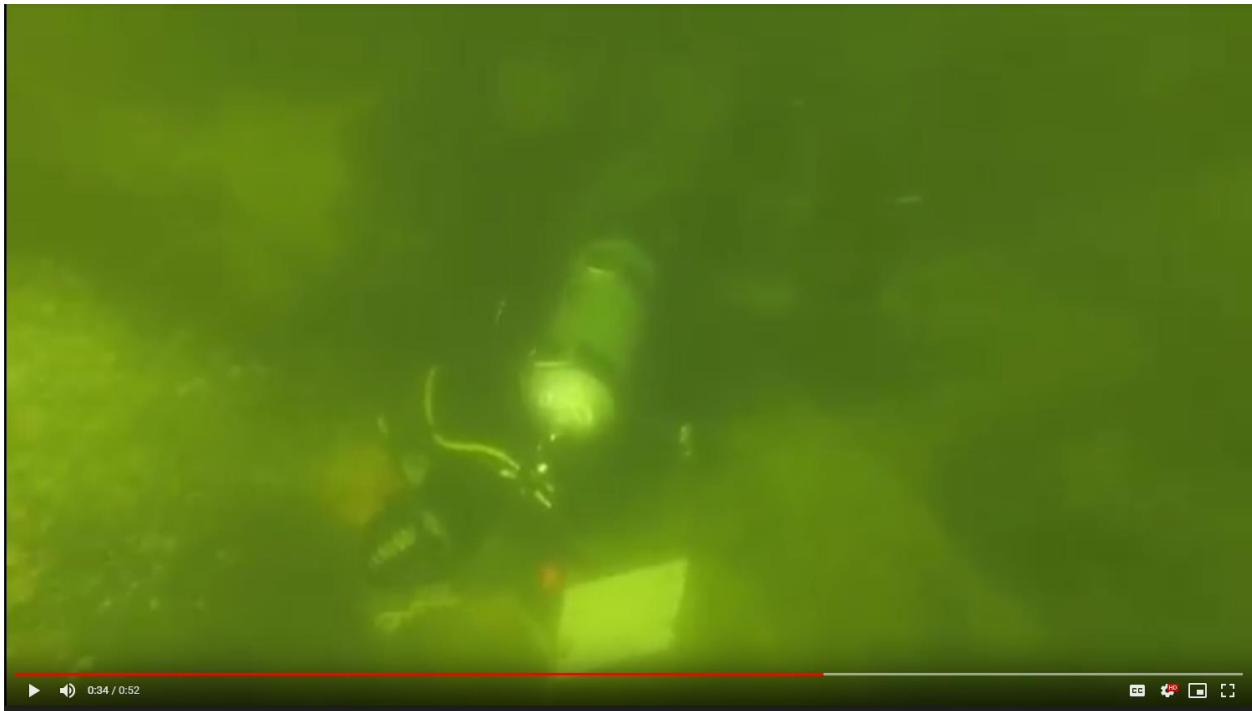
Photo 16: Screen grab taken from the GoPro video shot at the beginning of the incident dive showing Diver One's cylinder canted to the left due to the length of the drysuit inflator hose attached to the suit inflator on his left thigh.
