## **U.S. Geological Survey**

# **Serious Accident Investigation Factual Report**

## **Fatal Diving Accident at Torch Bay, Alaska**

**Date of Accident  
August 7, 2019**

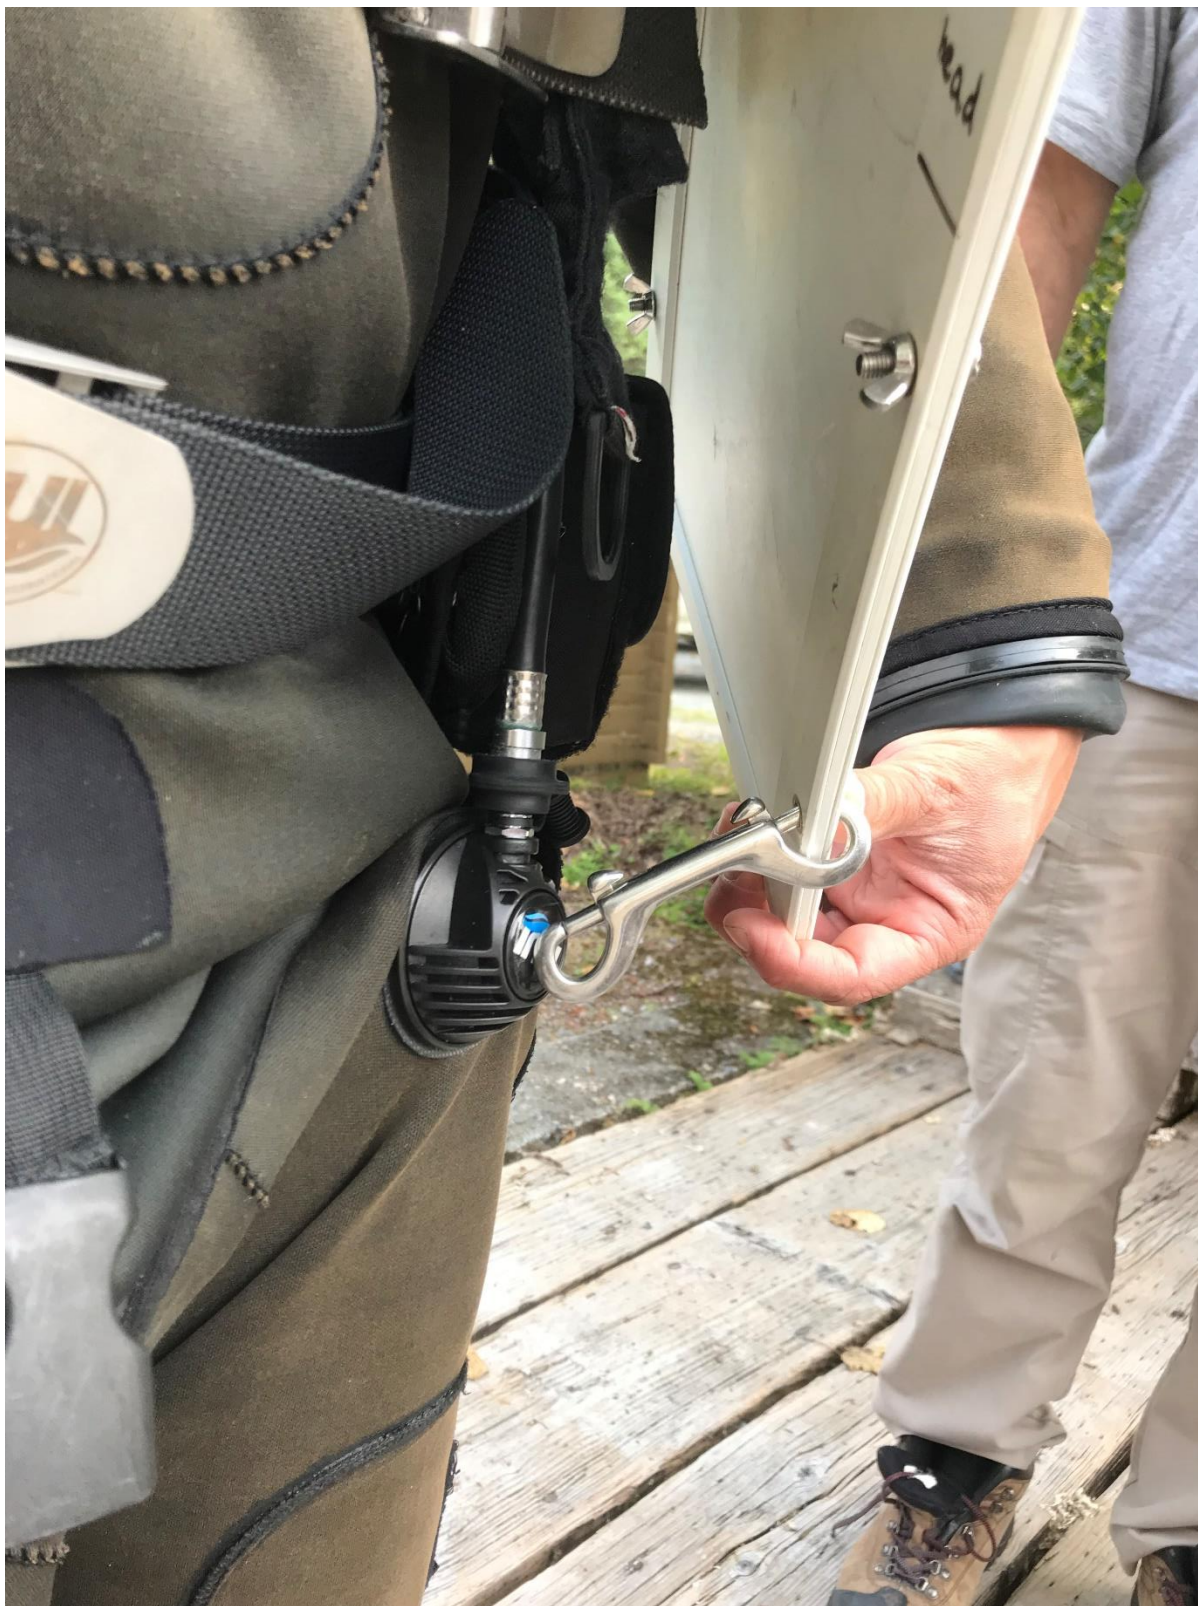
end clip attached through the hole in the slate designed for a screw and wingnut landed perfectly in the middle of the drysuit inflator button and pushing on the slate activated the button ([See Photo 17](#)). It was also noted that the double-end clip was positioned over the inflator button only when the gate of the brass clip securing the slate to the left shoulder D-ring was oriented facing the diver, as it would have been if attached using the diver's thumb to open the gate and moving the clip down onto the D-ring ([See Photo 18](#)). Diver Nine then assumed a pushup position to simulate the horizontal position Diver One had been observed employing near the bottom on the incident dive. With the slate beneath the diver and the clip facing up toward the diver, applying downward force associated with a prone diver settling to the bottom caused the clip to activate the button ([See Photos 19 & 20](#)). **NOTE:** During this testing process, sufficient force was applied to fracture the edge side portion of the slate material holding the clip in place and two small pieces of material broke off. It is unknown if cracks in the material were present prior to this test.

Photo 17: Data board clipped to the left shoulder D-ring of the Buoyancy Compensator Device (BCD) showing the natural fall of the clip to the drysuit inflator.

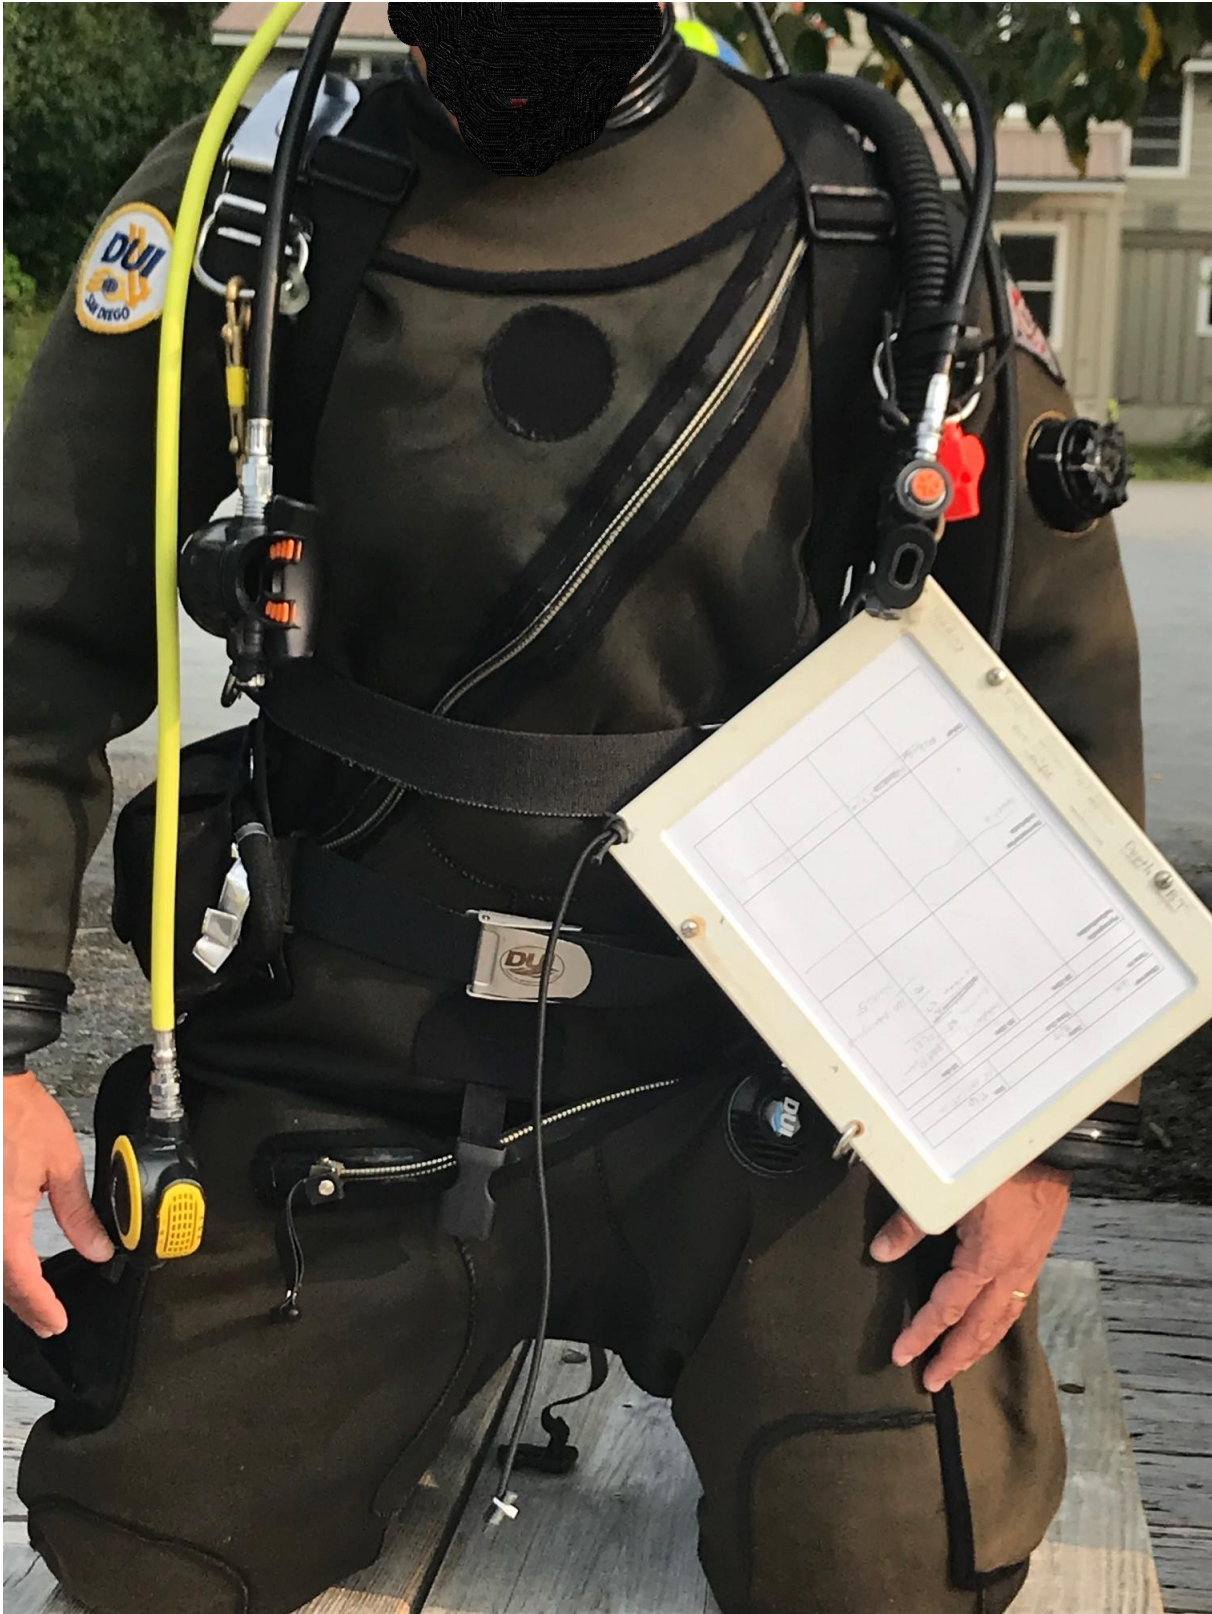
Photo 18: SAIT test of data board with stainless steel clip clipped to the left shoulder D-ring of the BCD in suspected pre-incident position.

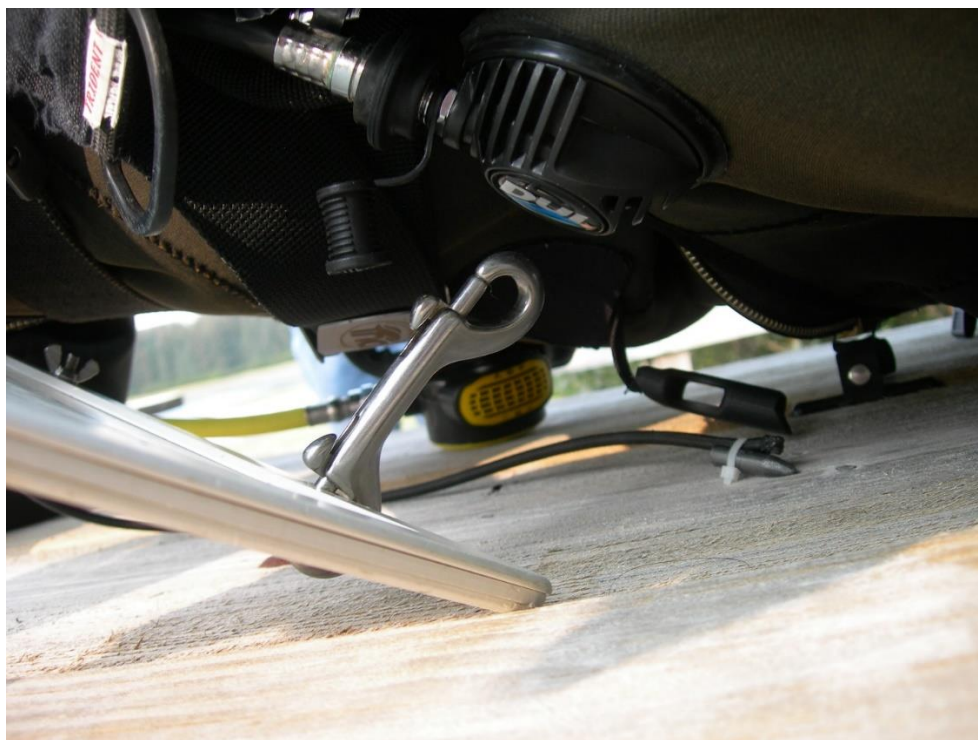
Photo 19: Data board attached to BCD and showing how the attached stainless steel clip lined up with the button of the inflator valve of the drysuit with the corner of the data board in contact with the “bottom”.

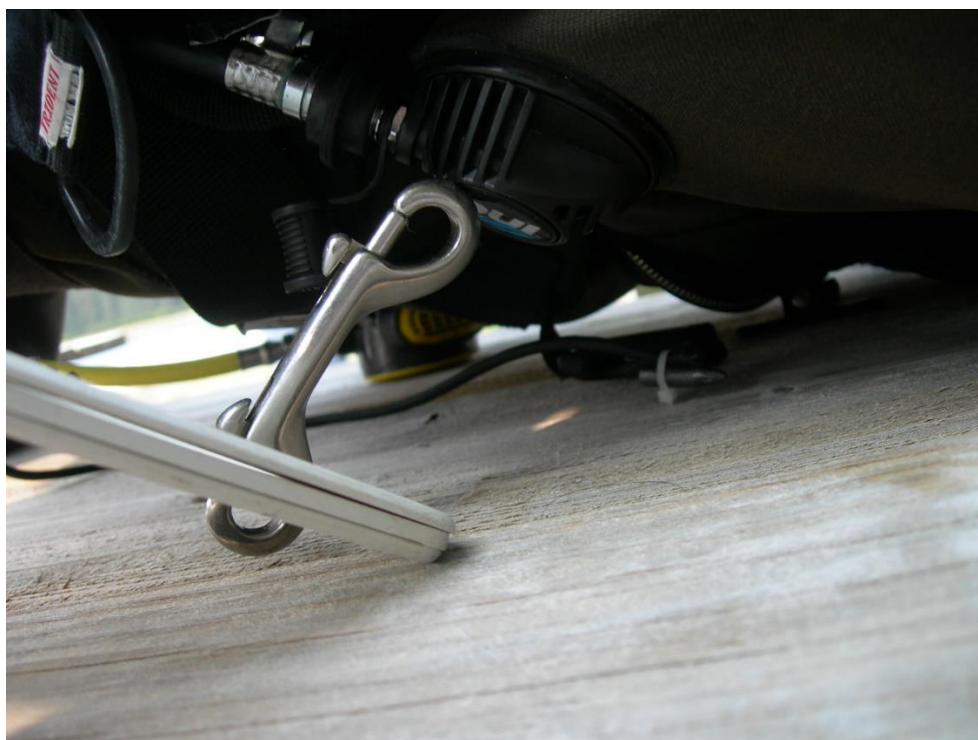
Photo 20: Data board clip contacting inflator valve during inflation test.
