## **U.S. Geological Survey**

# **Serious Accident Investigation Factual Report**

## **Fatal Diving Accident at Torch Bay, Alaska**

**Date of Accident  
August 7, 2019**

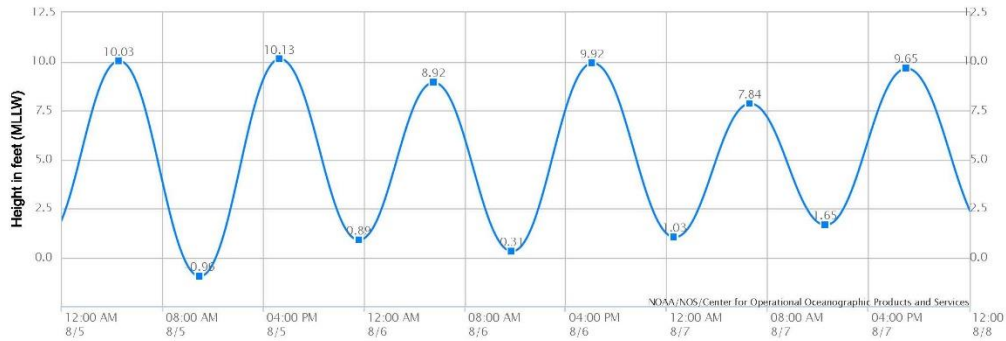
NOAA/NOS/CO-OPS  
Tide Predictions at 9452704, Graves Harbor AK  
From 2019/08/05 12:00 AM LST/LDT to 2019/08/07 11:59 PM LST/LDT  
Subordinate Station | Ref. Station (Elfin Cove 9452634) | Time offsets (high: 4 min. low: 7 min.) | Height offsets (high: \*0.91 ft. low: \*1.03 ft.)
